Innovative Passive Ventilation Water-Resistive Barriers— How Do They Work?

ABSTRACT

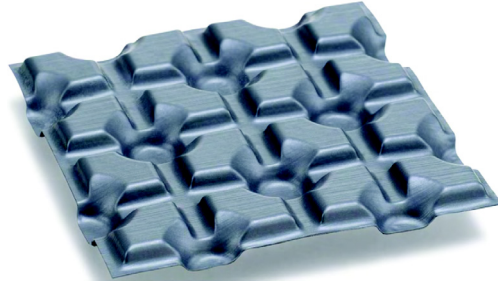
Figure 1 Impermeable three-dimensional polyethylene membrane with ventilated air-gap.

A proposed solution to minimize the risk of these moisture problems is the use of a vapor-impermeable ventilated air-gap membrane behind absorptive claddings. A three-dimensional polyethylene membrane will preclude inward solar moisture drive, and at the same time it allows water vapor within the wall cavity to diffuse into the ventilated air-space behind or inside the three-dimensional membrane and escape to the exterior. Hence the three-dimensional membrane allows a method of mass transfer to occur that is more effective than vapor diffusion: Air transport dries out both, the cladding and the sheathing board at the same time. An example of a three-

dimensional vapor impermeable membrane with ventilated air-gap is shown in Figure 1.

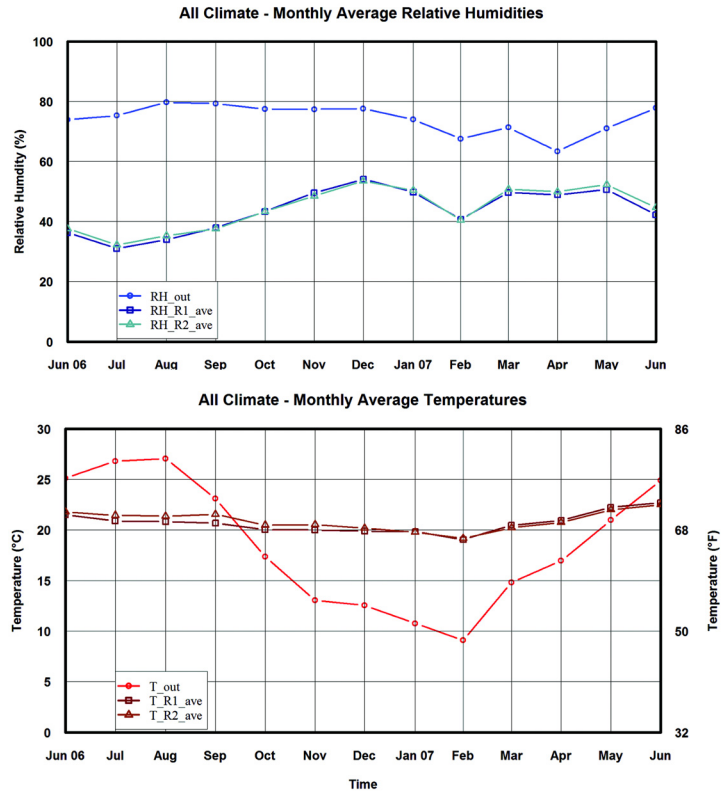
Figure 4 Interior and exterior relative humidity and temperatures during testing in Charleston, SC.

The interior and exterior boundary conditions simulated normal conditioned spaces and were measured and recorded over the entire test period. The interior (R1 = room 1; R2 = room 2) and exterior temperatures and relative humidity for Charleston, SC are shown in Figure 4.

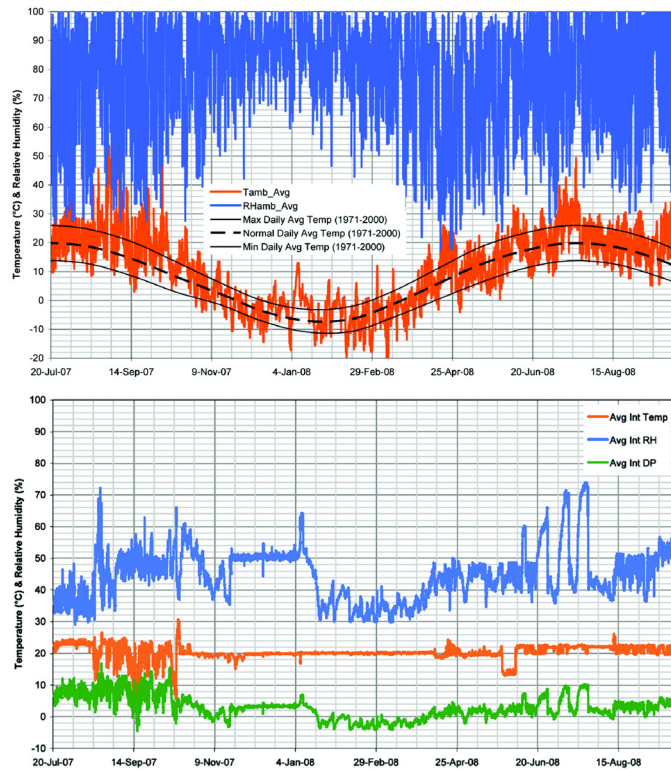
Figure 5 Interior and exterior relative humidity and temperatures during testing in Waterloo, ON.

The interior and exterior temperatures and relative humidity for Waterloo, ON are shown in Figure 5.

The periodic increase of relative humidity in the Waterloo testing period did not affect the hygrothermal conditions in the test walls, since these walls had continuous polyethylene vapor barriers.
